张家港市海宇金属材料测试有限公司
Zhangjiagang Haiyu Metallic Material Testing Co.,Ltd.

TEST REPORT

样品名称 Description of Sample	圆棒 Round bar	检测日期 Testing Date	2015-10-30~2015-10-31
试样编号 Number of Sample	15H1030-26	牌号/规格 Grade/ Dimension	UNS S32760 / F55
检测地点 Place of Test	光谱室、金相室、腐蚀室 Spectrum laboratory、Metallographic laboratory、Corrosion laboratory	环境条件 Environmental Conditions	温度(TEMP.): 22°C 湿度(Humidity): 60%
样品状态 Sample State	<p>Φ 28×210mm 试样 1 件。 1 piece of specimen of Φ 28×210mm.</p>		
客户编号 Number of Client	炉号: 14-3451 Heat No.

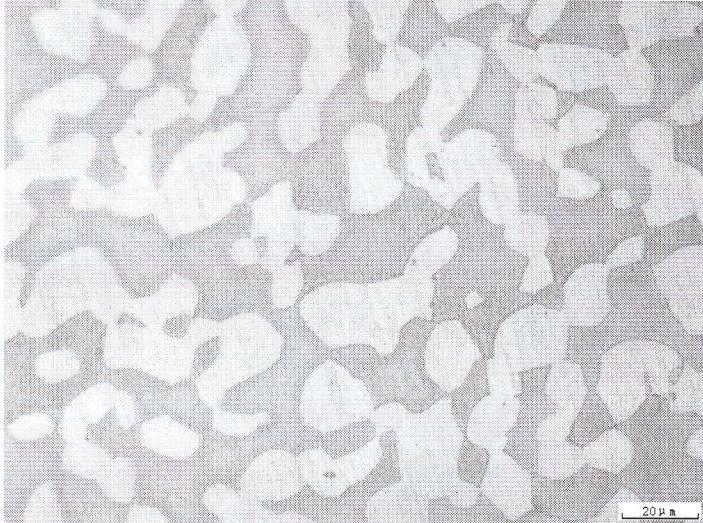
检测项目 Item of Test	检测结果 Result of Test	说明 Comment
显微组织 Microstructure	铁素体+奥氏体，铁素体含量约占 46%。 Ferrite and austenite, ferrite account for 46%.	见图 1 see Fig.1

图 1、显微组织 500×
Fig.1、Microstructure

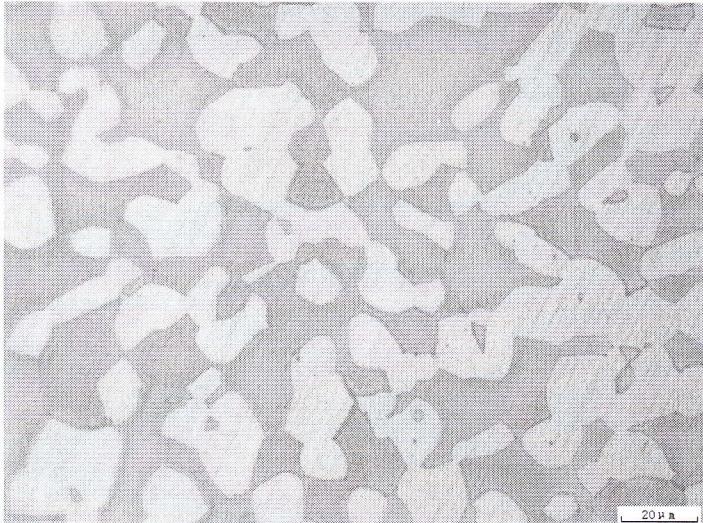
见图 2 see Fig.2

检测项目 Item of Test	检测结果 Result of Test	说明 Comment
用于双相不锈钢腐蚀组织分类的 氢氧化钠腐蚀试验 Sodium Hydroxide Etch Test for Classification of Etch Structures of Duplex Stainless Steels	<p>按 ASTM A923-14 方法 A, 试样经氢氧化钠电解液腐蚀后, 用 500 倍显微镜观察, 铁素体已腐蚀, 金属间相未显现, 相间的边界是光滑的, 浸蚀组织属未受影响的组织。</p> <p>According to ASTM A923-14 Method A, the specimen was observed under 500× microscope after it was etched by electrolyte of sodium hydroxide, the ferrite has been etched without revelation of intermetallic phase, the interphase boundaries are smooth, the etch structures is unaffected structure.</p>

图 2、金相照片 500×
Fig.2、Metallographic photo
